Navajo Abandoned Uranium Mine Site Screen Report

Crownpoint, Section 9 AUM Site

Navajo AUM Eastern Region

Weston Solutions, Inc.

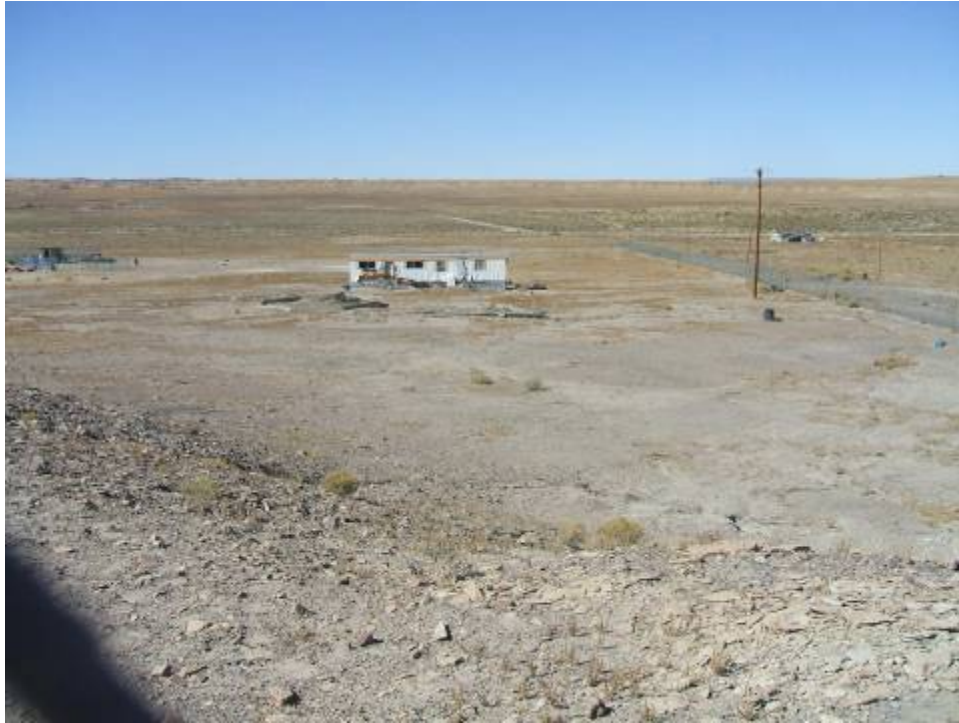
No ownership was identified. The mine site property is classified as Indian Allotment land. A trailer is currently located in the eastern portion of the site, although it appears to be uninhabited (Photo 1). The majority of the site, with exception of the western extension, is fenced in, and was inaccessible during the site visit.

0 to 200 feet: A trailer home is located in the eastern section of the site, it appeared to be uninhabited. A horse stable was also observed near the trailer (Photo 1, 2)

Photo 1. Crownpoint Section 9, trailer within fenced-in area, towards the west

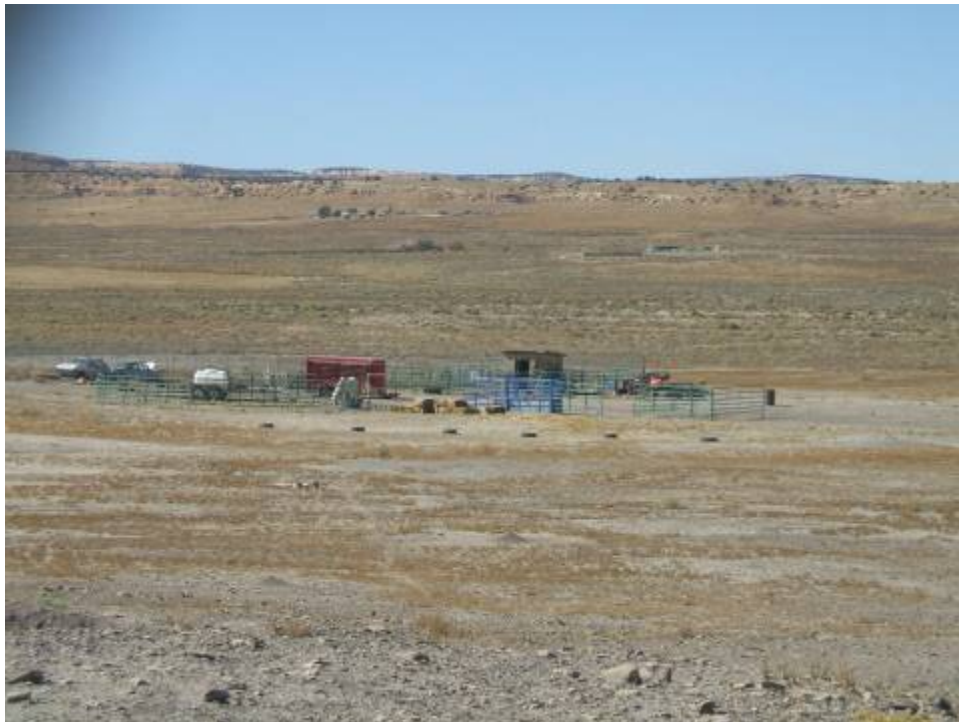
Photo 2. Crownpoint Section 9, stables within fenced-in area, towards the west

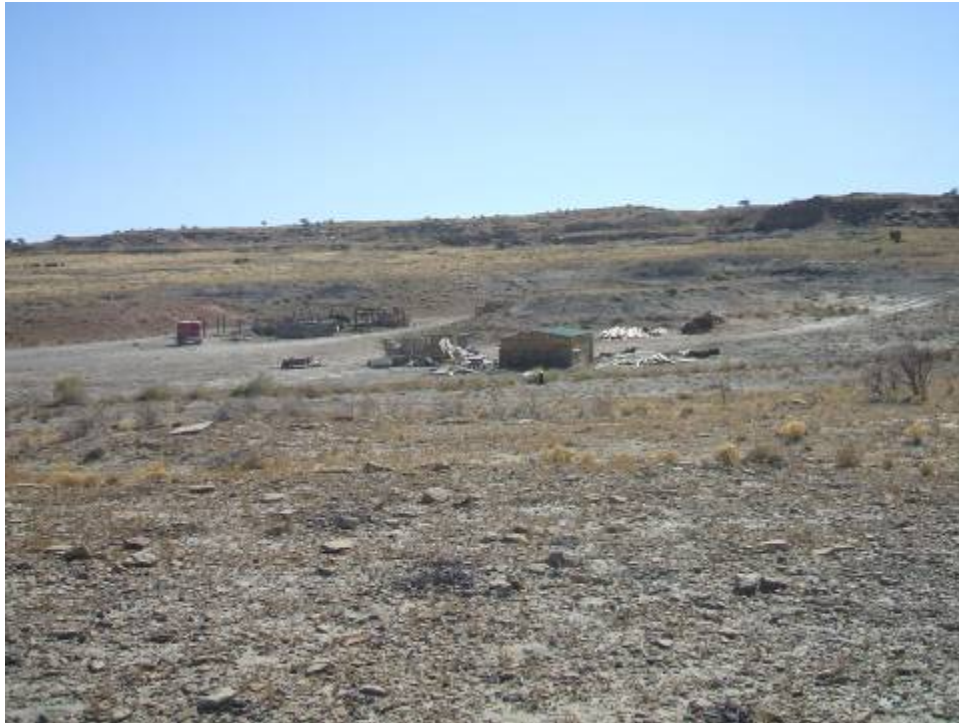
200 feet to 0.25 mile: A house was located 200 feet north of the western portion of the site (Photo 4). Gamma radiation levels collected near the house were below 2 times background levels. A horse stable was also observed approximately 200 feet east of the site (Photo 3). No residents were encountered at either feature.

Photo 3. Wooden shed and stables directly east of site perimeter fence, towards the east

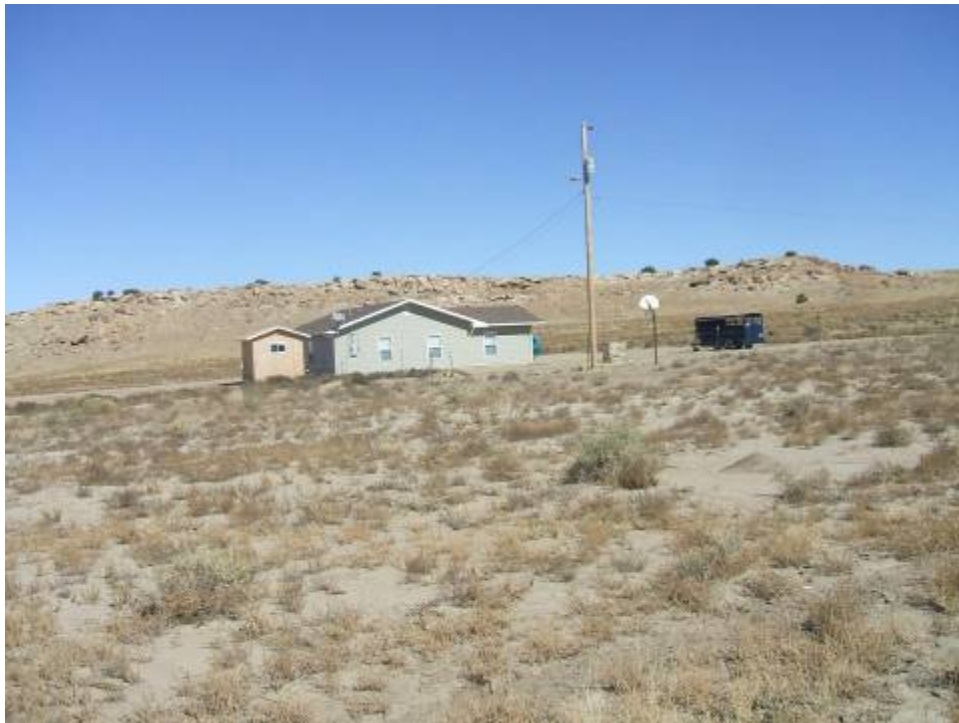
- House north of site – measured at less than 2 times background levels

Photo 4. House approximately 200 feet north of mine site, towards the north

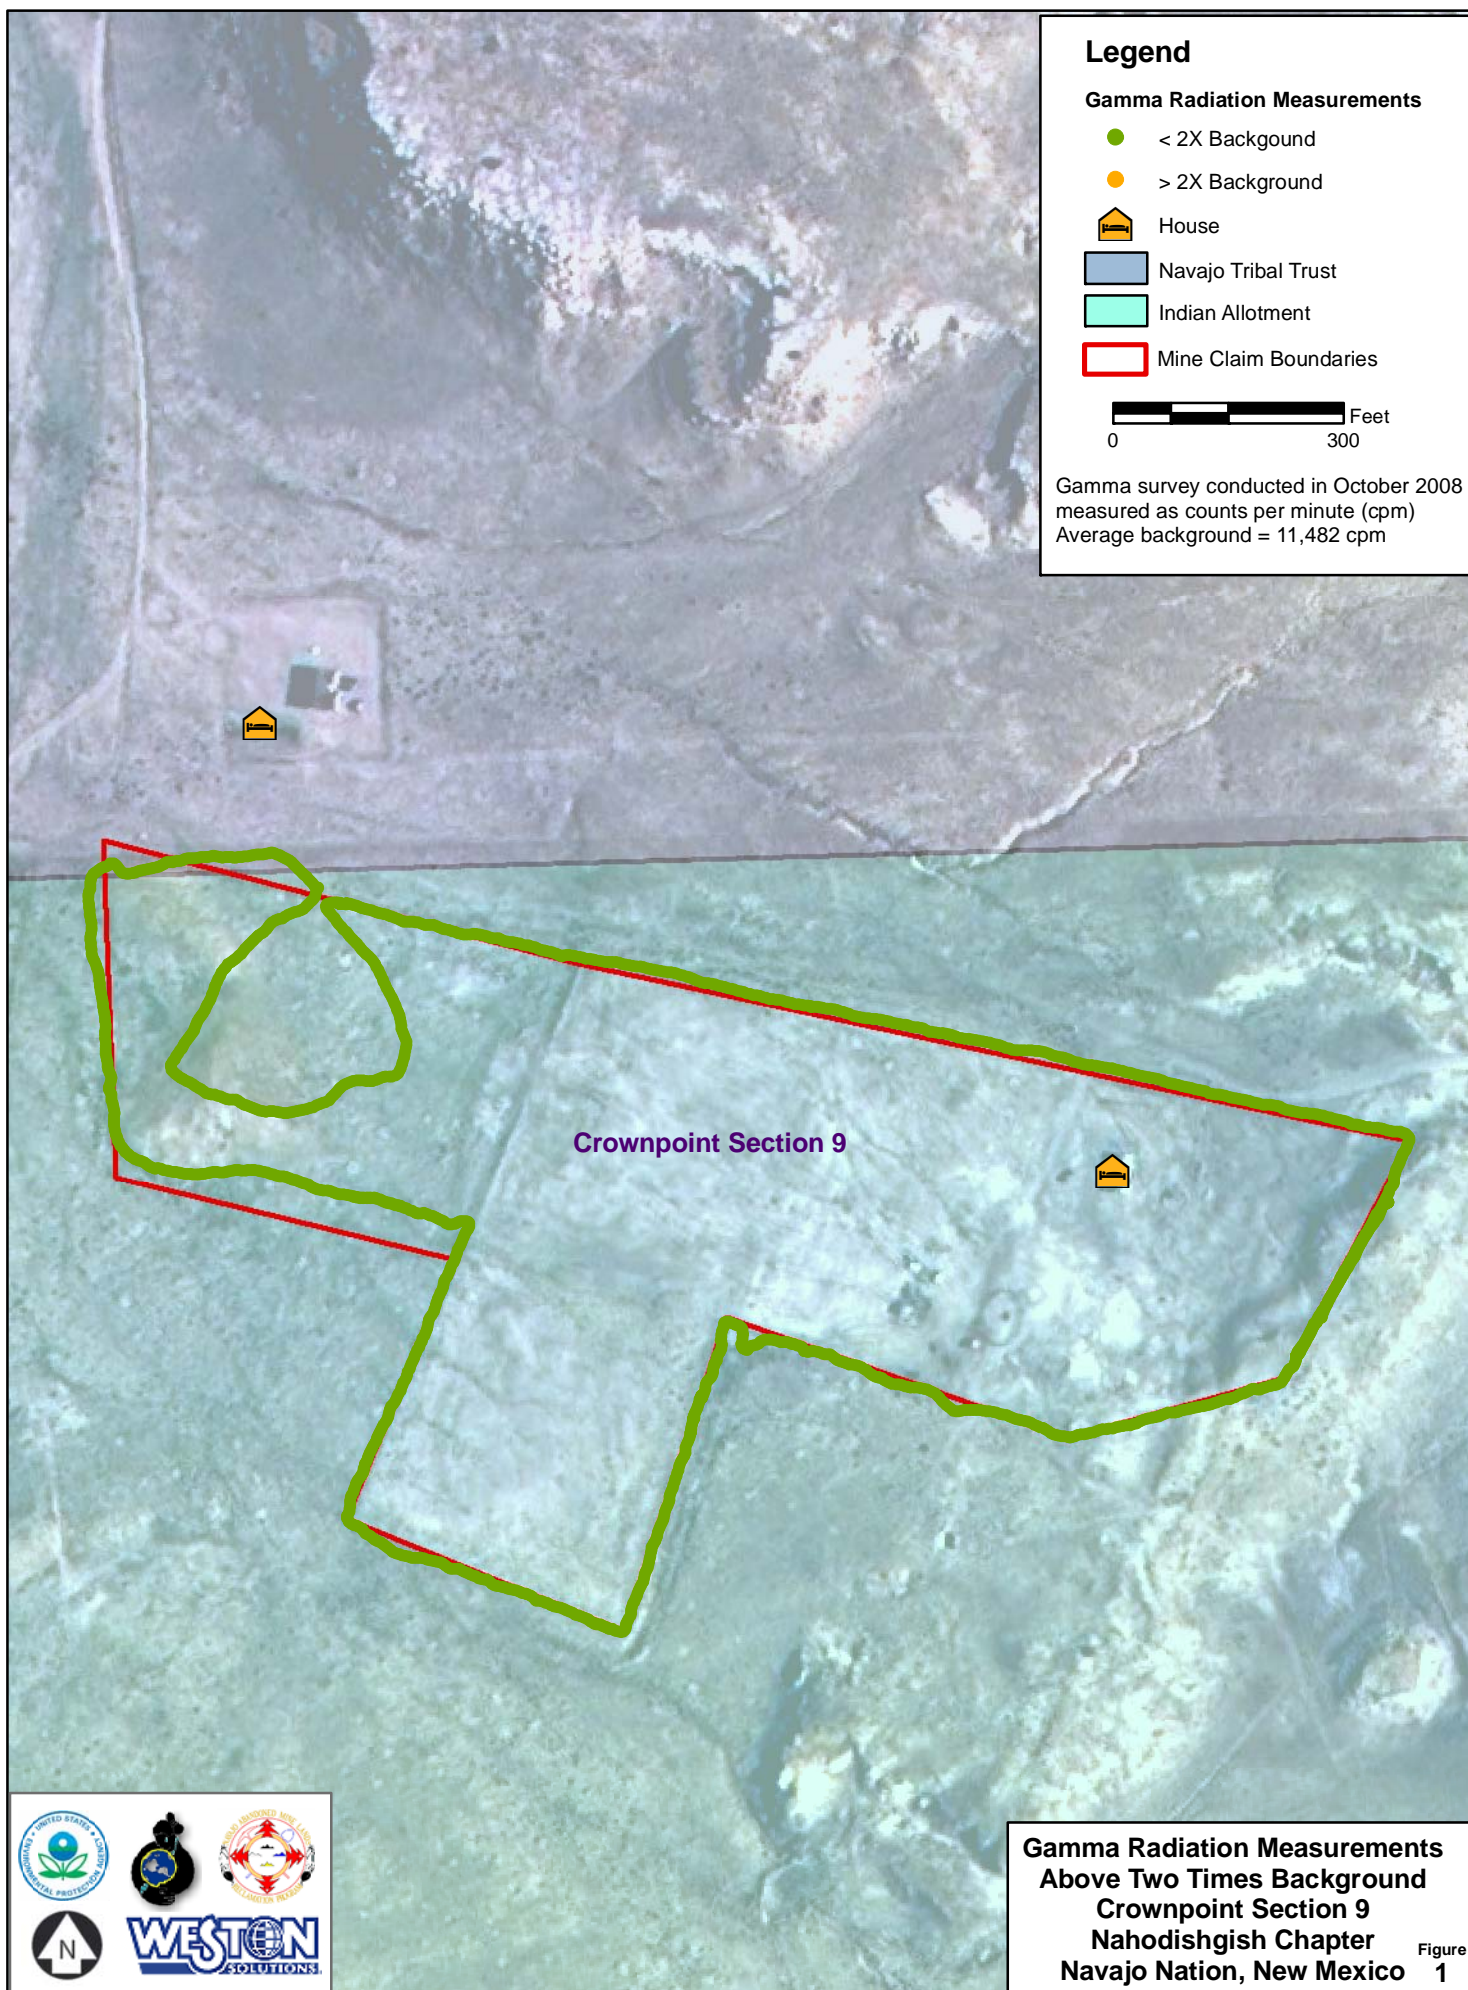
A total of 1,717 gamma radiation measurements were collected from mine sites, ranging from 8,951 cpm to 15,386 cpm. The measurements are represented in Figures 1 and 2.
